RENOVATION OLD ELBTUNNEL, HAMBURG

Renovation old Elbtunnel, Hamburg, Germany

Total restoration of the vault, banquette including utility ducts of the antique single track road tunnel under the Elbe, linking the parts St. Pauli and Steinwerder of the city of Hamburg.

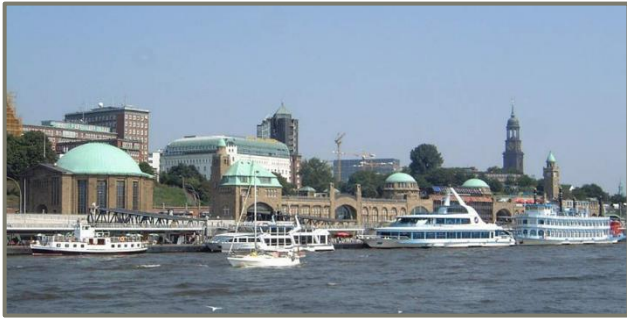
- Shaft of the entrance at St. Pauli

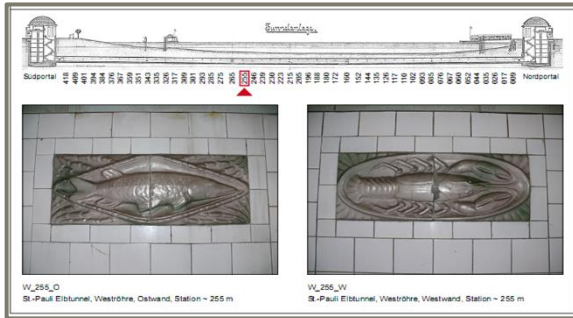
- Historic parts at tunnel walls to be preserved

- Removal and preservation of the original tiles covering the walls for later reinstallation
- Removal of cast in place concrete to free the steel segments.
- Removal of bad lead joint sealing between the segments
- Difficult site access and logistics
- Special measures for work safety (breathing masks, protective clothing).
- Placement of additional weights when removing material for avoiding of buoyancy of entire tunnel.

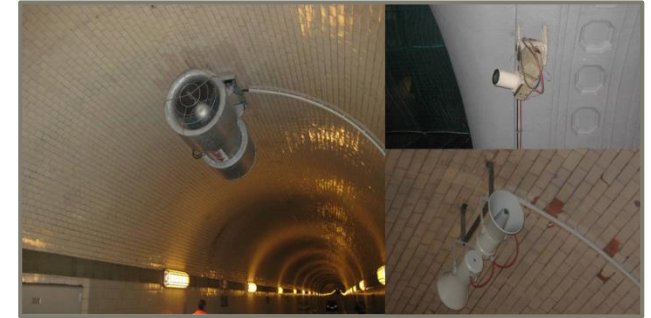
- Restored part of tunnel, new safety installations

- Installation of a temporary transport route with wooden planks.
- Sideways to be removed and placed back after renovation of building structure.
- Imperative preservation of authenticity, placing the historic relief tiles after restauration to the walls and ceiling.
- Safety installations and automatic ventilation as well a modern technique (i.e. gas alarm) needed to be integrated in harmony with the historic building substance

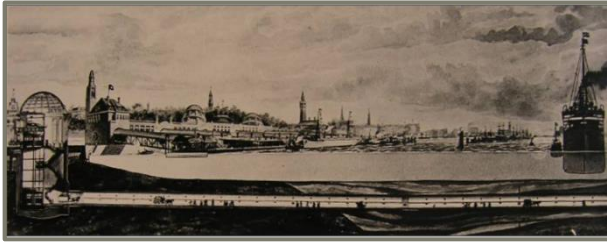
■ Antique section drawing of Elbtunnel

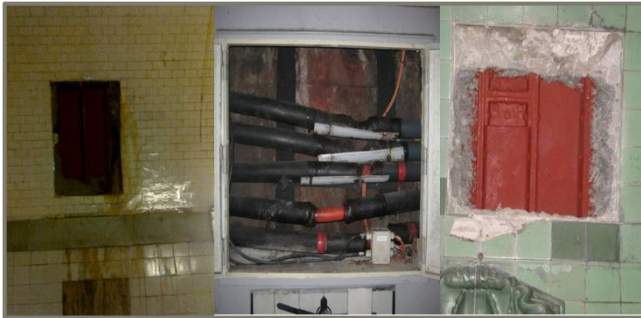
■ Deterioration of tunnel, utilities and steel segments

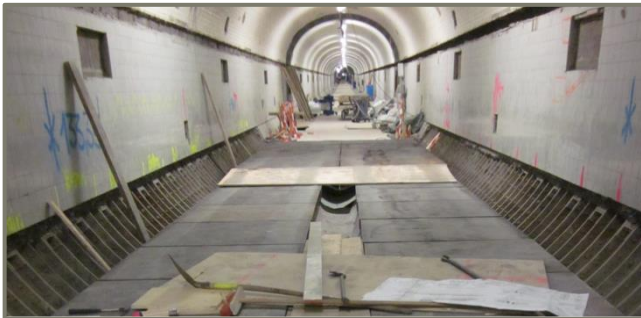
■ New sealing and utility ducts in roadway area

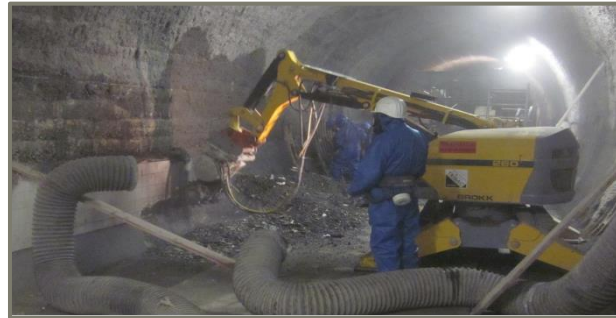
■ Removal of lining concrete

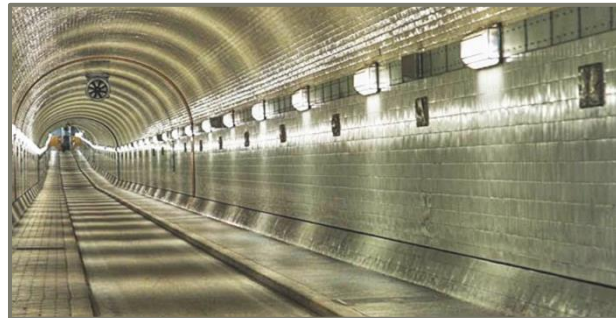
■ After restoration, showing new installations (safety)

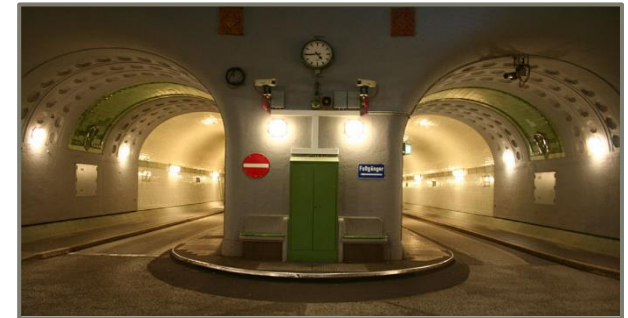
■ View of subsurface tunnel portals

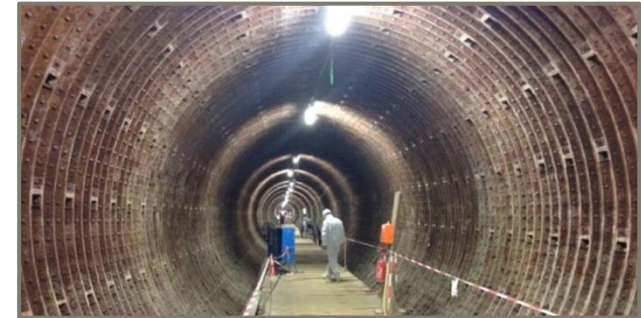
■ Corroded steel segments after concrete stripping
